# Buildings and Structures Asset Management Plan

November 2011

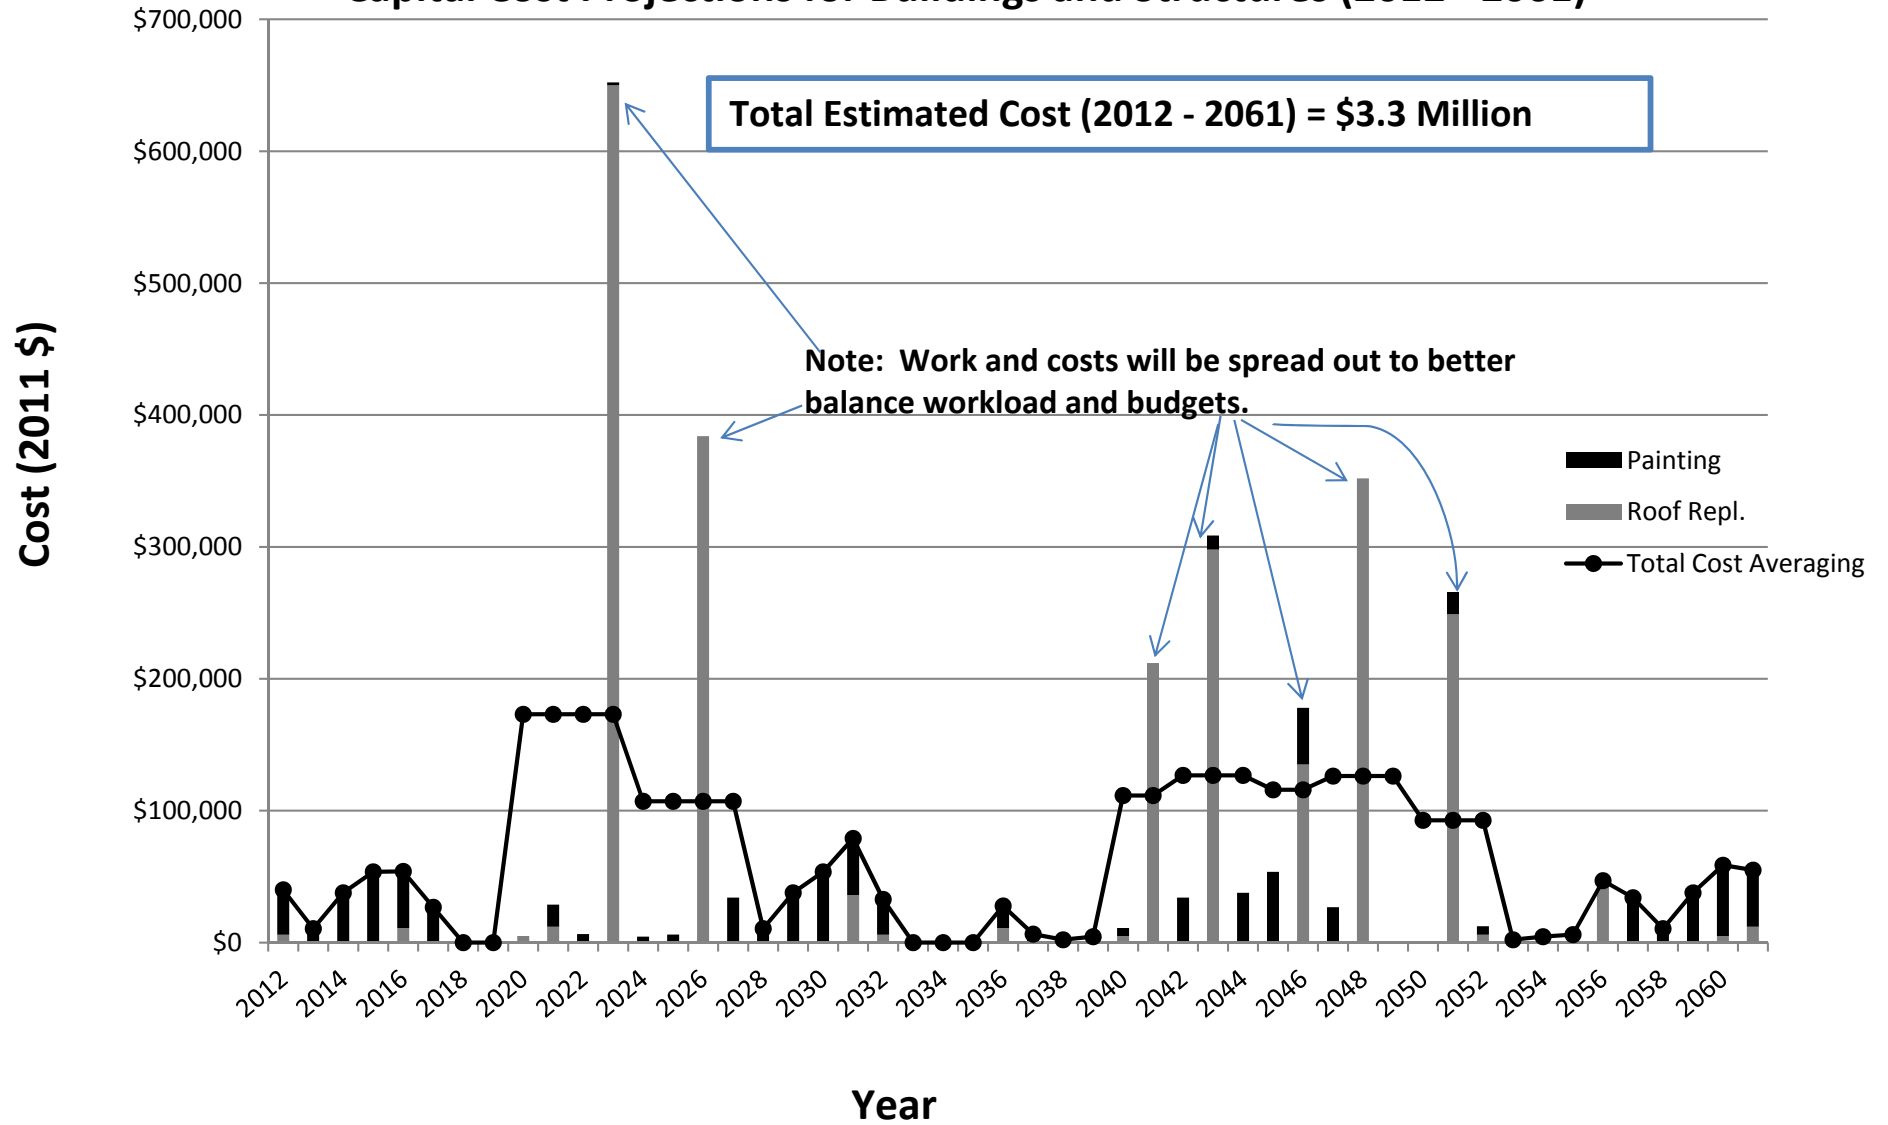
**Figure 1**  
**Capital Cost Projections for Buildings and Structures (2012 - 2061)**

Capital costs for building and structure roof replacements and painting have been projected out 50 years (2012 – 2061) and are shown in Figure 1. The cost data is also included in tabular form in Appendix C. As noted, over the entire 50 year period, total capital cost expenditures are estimated at approximately \$3.3 million (in 2011 \$).

**Figure 1 – Capital Cost Projections for Buildings and Structures (Roof Replacement and Painting), 2012 – 2061**
